**Impacts of Unauthorized Construction-Derived
Contaminated Soil Disposal in Quebec: A Case Study of
Rang Dumas in the Chateauguay River Watershed**

Alex DePani
McGill University

July 17th 2023

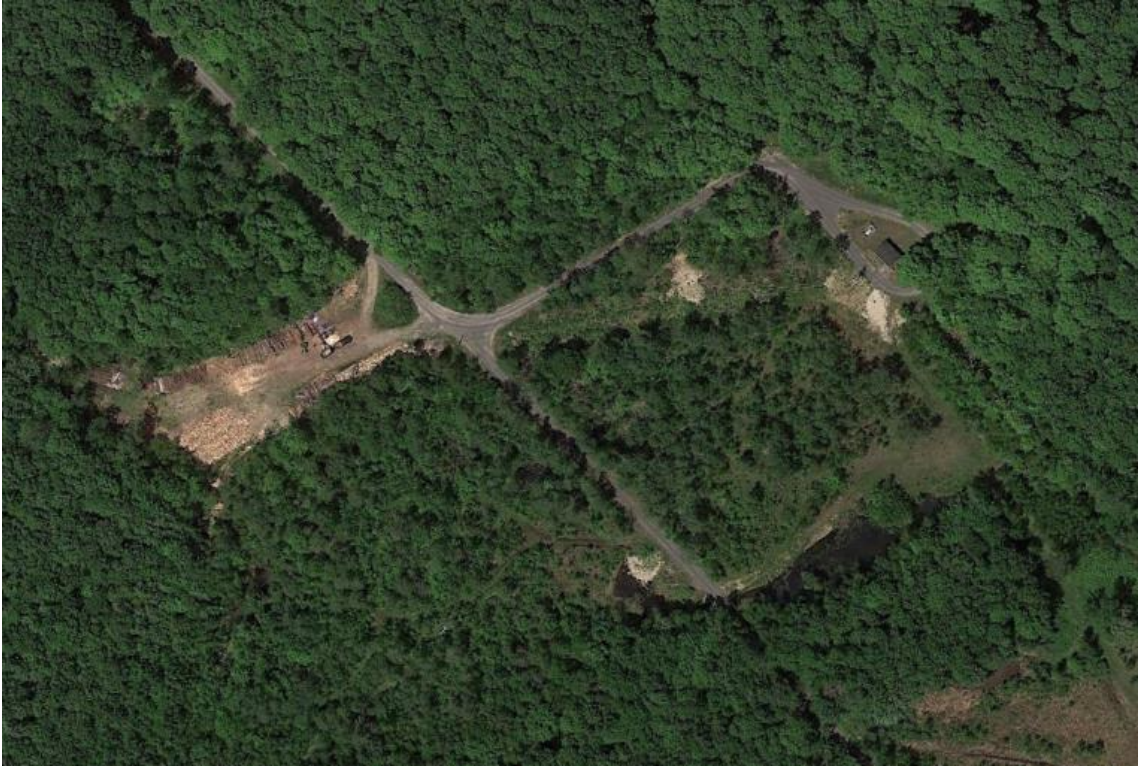
Figure 1 – June 2nd 2018 Satellite Imagery of the Rang Dumas Property (Google Earth Pro 7.3.6.9345, 2022)

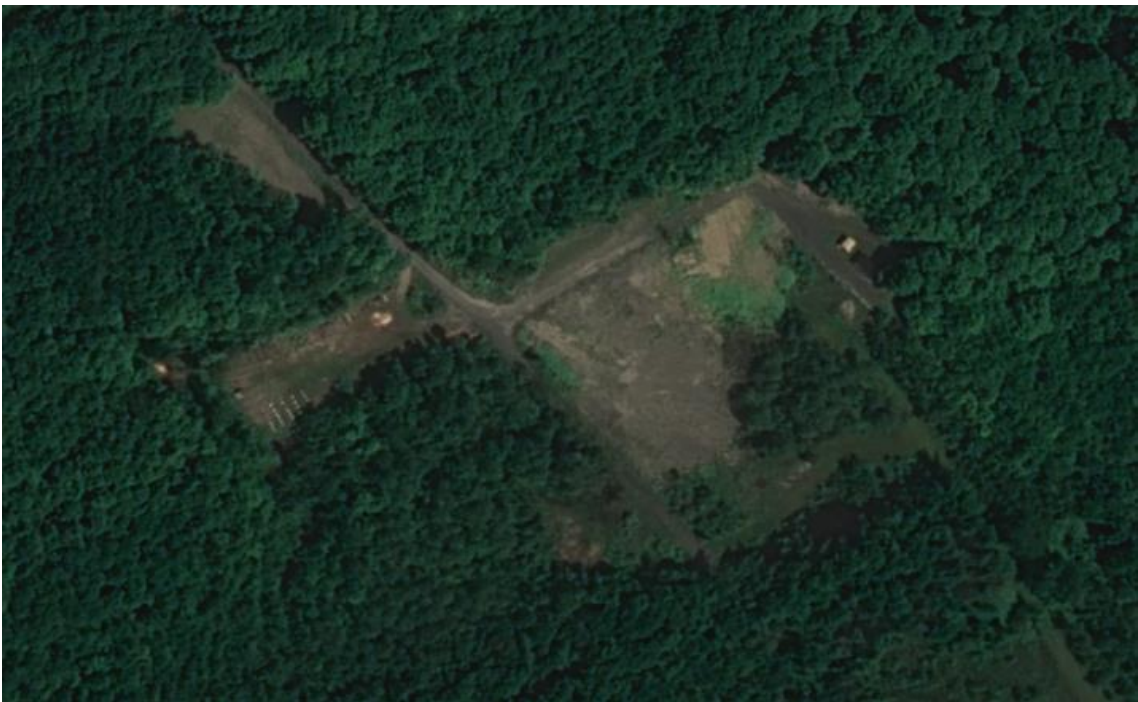
Figure 2 – July 6th 2023 Satellite Imagery of the Rang Dumas Property (UP42, 2023)
